**ENGINEERING EVALUATION OF THE RED BLUFF RESEARCH
PUMPING PLANT ON THE SACRAMENTO RIVER IN NORTHERN CALIFORNIA:
1995-1998**

**A Summary Report
Red Bluff Research Pumping Plant
Report Series: Volume 6**

**K. W. Frizell
Bureau of Reclamation
Water Resources Research Laboratory
P.O. Box 25007
Denver, CO 80225-0007**

September 1999

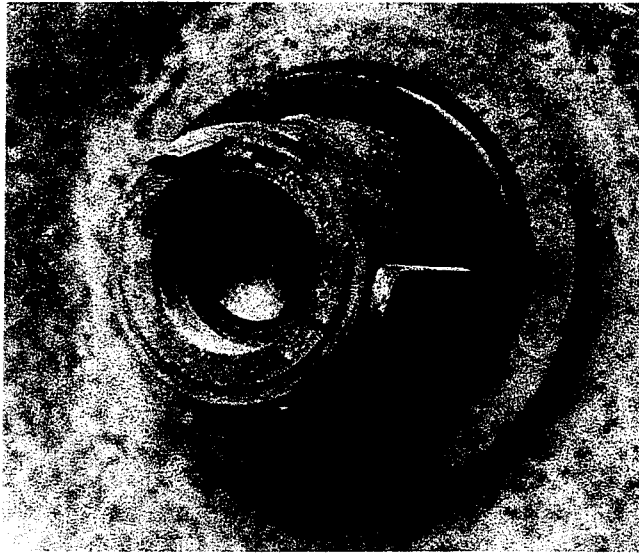
centrifugal pump was used to begin the biological evaluations. The pump operation was initially very smooth; however, over the course of only 254 hours, shaft runout and pump noise forced the pump to be shut down on September 14, 1995. Upon inspection of the pump, it was discovered that the impeller had shifted radially along the pump shaft impinging the impeller on the intake manifold. A broken shaft had caused the pump to seize, figure 26. The impeller was shipped to the manufacturer's plant in Salt Lake City, UT, where it was discovered to be extremely out of balance. A new shaft was

Figure 26. Broken shaft on Wemco pump. First occurrence of broken shaft, likely due to fatigue damage.

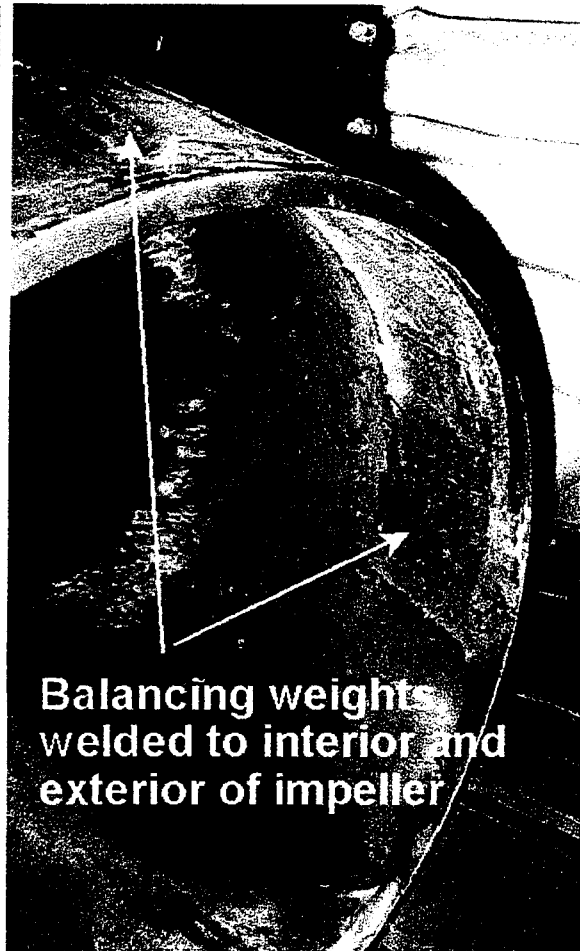
The pump was re-started on July 23, 1996, and ran intermittently for 141.5 hours, until September 3, 1996. Throughout this period of operation, the pump had been experiencing a hydraulic imbalance, most likely caused by the balancing weights that were added to the exterior of the impeller. Pressure fluctuations of about ± 20 lb/in² were recorded in the pump casing. Noise and vibration increased in intensity with the number of hours of operation. Towards the end of this operational period, packing material began shredding and appearing in the stuffing box area. The manufacturer concluded that the hydraulic loading was too great, and decided to cast a new impeller which could be dynamically balanced without adding extra material to the casting.

Figure 27. Balancing weights added to Wemco impeller. Steel plates were welded to the interior and exterior surfaces of the impeller to allow dynamic balance.

manufactured in Peru and shipped to the Utah facility where the impeller-shaft assembly was dynamically balanced, requiring welding over 100 lbs of steel plates to the interior and exterior surfaces of the impeller, figure 27.

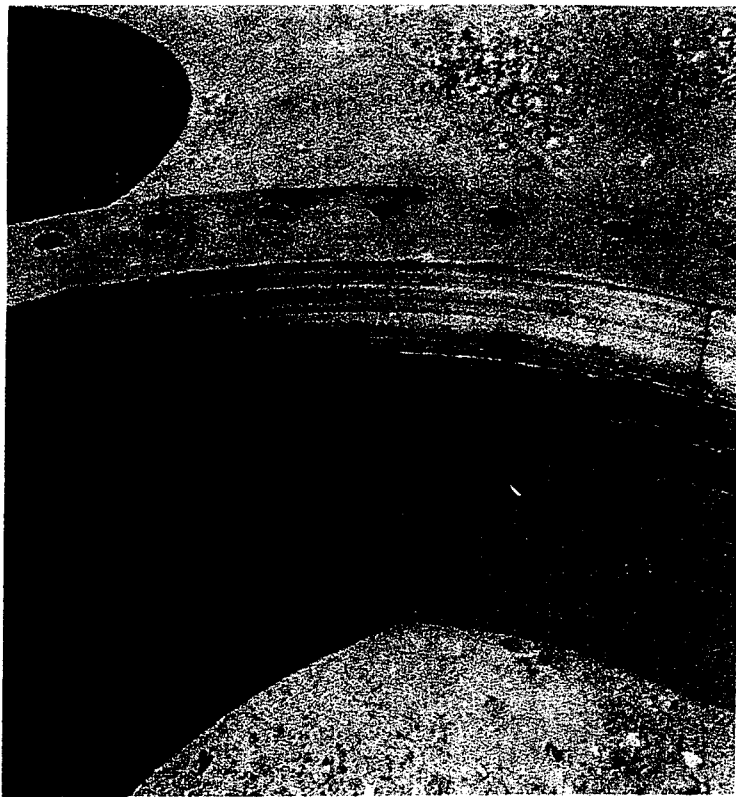
Rotating Seal. Within the 8-hour period of the initial burn-in test, shavings of UHMW (Teflon) seal material (between fixed pipe and rotating pump) were discovered in the discharge channels of the Archimedes pumps, and were accumulating on the wedge-wire screens. Upon closer inspection of the pump, it was determined that sediment from the river was migrating through the packing and lodging between the seal and the fixed roller pipe. This caused the seal to wear excessively. The pumps were shut down and the seal and packing were disassembled. Sediments in the size range of 1/8 inch and smaller had lodged between the UHMW seal and the fixed pipe, causing scoring and excessive wear of the relatively soft seal material, figure 14. Sediment traps were considered as a means to eliminate the sediment from the water prior to entering the intake manifold. This solution was quickly discounted due to the detrimental effects it would have on the inlet velocity and its low probability of success. A redesign of the seal was needed to allow operation with any amount and size of suspended sediments that may be pumped from the river. After several months of unsuccessfully working with the manufacturer to develop a solution without success, Reclamation designers developed a seal which could be manufactured and installed quickly and inexpensively. The seal eliminated large quantities of mechanical equipment and consisted

Figure 14. UHMW seal ring. *Wear and scoring on UHMW seal ring on Archimedes pumps, due to sediment intrusion.*

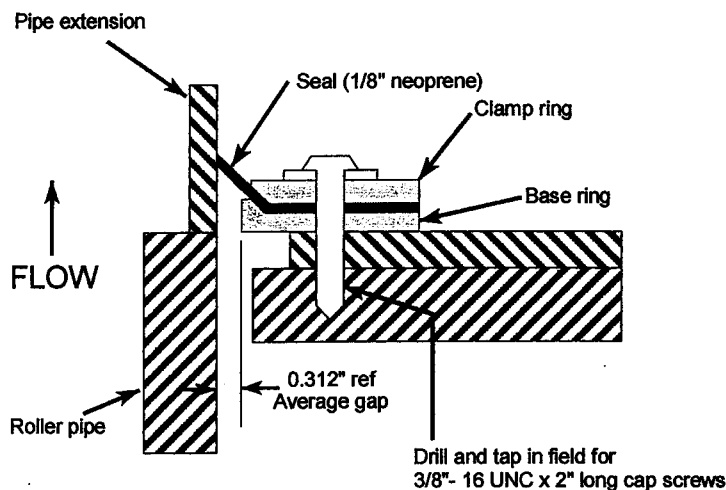
Figure 15. Schematic of modified Archimedes inlet seal. *Detailed schematic of modified rotating seal installed in the two Archimedes pumps at RBRPP, photo shows detail of actual installation.*

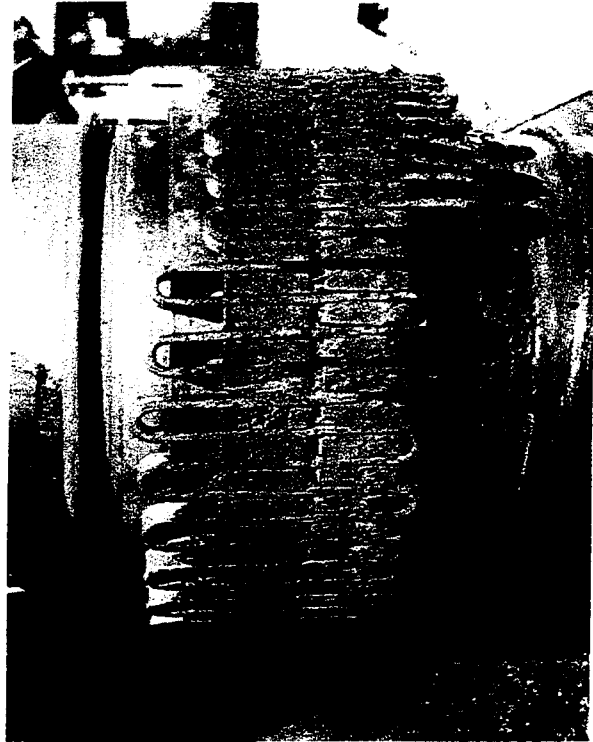
Low-Speed Coupling Failure. In late May 1996, both pumps were dewatered and a major inspection was performed. The inspection began with the low-speed couplings due to the known failure on pump 2. The low-speed couplings, manufactured by Falk Couplings, are used to couple the gear box reducer to the pump thrust bearing. The couplings used in the Archimedes pumps were model 1000T series tapered grid steel flex couplings with split covers, type T10, size 1200T. The service manual gives the alignment limits for installation of the couplings as a maximum offset of 0.015 inch and within 0.027 inch of angular alignment. Lubrication specifications also require the coupling to be filled with 12.5 lbs of grease prior to operation. Upon disassembly of the unit, it was noted that the coupling cover of pump 2 had a circumferential break between the center coupling fastener and the fastener on the driven side. After removal of the cover, subsequent inspection showed the grid had broken into several pieces, figure 16. Wear marks on the cover indicated that the coupling had broken and was rubbing on the cover. An estimated 1-2 lbs of grease was recovered from the coupling. The grease was very thick and extremely dry. Excessive wear was observed on the hub grid teeth on both the drive and driven hubs. Measurements of the mean tooth thickness for the new coupling had been 0.765 inch on both coupling halves. The measured thickness of the disassembled driven coupling hub teeth was between 0.610 to 0.630 inch and for the drive hub 0.657 to 0.682 inch, indicating a maximum wear of 0.155 inch and 0.108 inch, respectively. The low-speed coupling offset and angularity were then measured. The offset was 0.110-inch top to bottom and 0.21-inch side to side. The face-to-face angularity measurement looking toward the driven unit are given in Table 1. These measurements reflect a maximum angularity of 0.226-inch top to bottom and 0.033-inch side to side.

Figure 16. Damaged low-speed coupling. Damage to low-speed coupling, Pump 2 (broken grid)

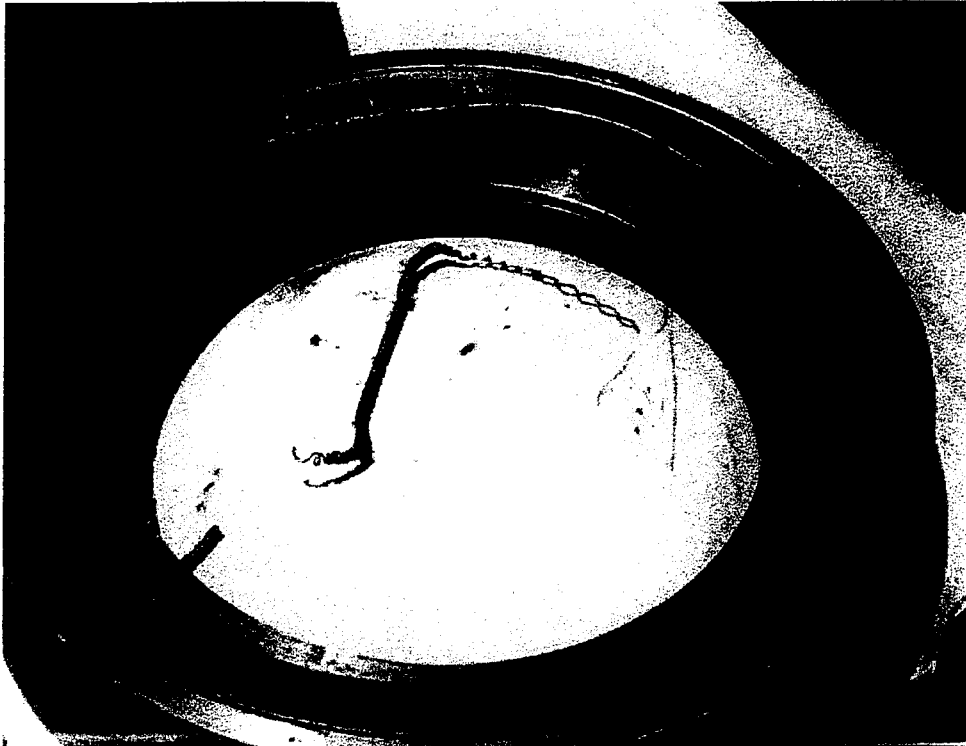
Due to the discovery of the metal shavings in the pump 2 thrust bearing housing, pump 1 was checked to determine if there were metal shavings in the housing. The oil was drained from Pump 1. Inspection of the oil showed a large amount of small metal flakes in the oil. Analysis of the oil was inconclusive as to the source of the metal flakes, but there were elevated levels of copper and iron as well as large particles detected in the oil. The FAG Bearing representative was contacted and the analysis of the oil discussed. The level of large particles obtained from the sample was of great concern to the bearing manufacturer, but the level of copper and iron were not greater than might be expected during initial running of the pump. Upon removal of the lip seal, visual observations indicated that the seal had suffered severe damage at some time. The steel shell was partially crushed, the rubber torn in many areas, and the garter spring was broken with portions missing. Damage also included a portion of the steel shell that had the appearance of a pry mark on it, figure 17. The lip on the cover that the seal rides on was grooved from seal wear and required machining. The missing portion of the spring and part of the rubber were in the bottom of the housing laying next to the roller bearing. The only way to inspect the internal surfaces of the bearing itself was to disassemble the bearing from the housing. There also had been deformation of the set screw on the locknut. The barrel and thrust bearing assembly of pump 1 were removed from the bay, figure 18. The thrust bearing assembly was shipped to Allied Engineering in Alameda, California for disassembly and inspection. Inspection of the bearing showed a small piece of the broken spring in between

Figure 17. Damaged seal ring from thrust bearing. *Damaged seal ring, note broken spring and pry marks on steel shell.*

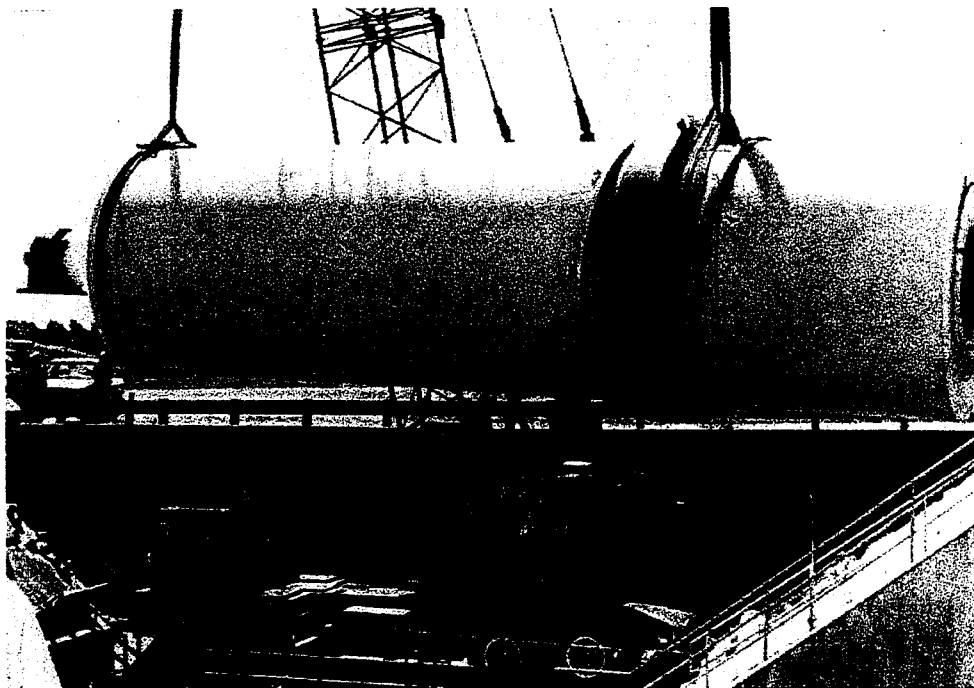
Figure 18. Removal of Pump 1 from bay. *Removal of pump 1 by mobile crane in order to repair thrust bearing.*

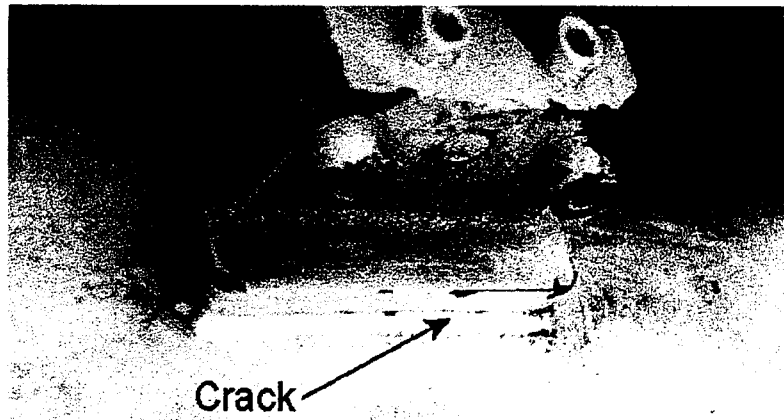
Figure 19. Saddle blocks on Pump 1. Saddle blocks used to attach wearing ring at lower bearing location. Note crack along perimeter of weld.

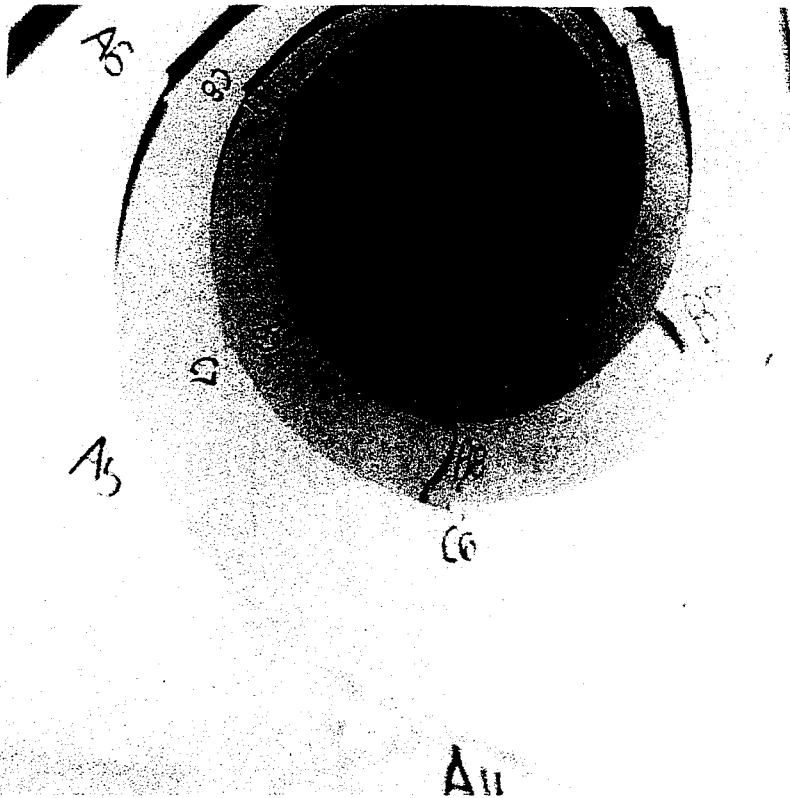
Continued crack formation and propagation led to analytical studies at Reclamation's Technical Service Center. Personnel ran a finite element analysis on the Archimedes pump to determine how the loading at various river elevations affected the pumps. The analysis indicated that the stresses on the pump flights were greater than the structure could support and hence the cracking. Finite element analysis indicated that a reinforcement of the flights was necessary to increase the flight strength. A spiral reinforcement ring 1/4-inches thick, 4-inches wide was installed on each side of the Archimedes flights, a minimum of 2 inches in from the leading edge. The plates were cut and shaped to conform to the existing curvature of the pump. The plates were then welded into place on both

Figure 20. Cracks on the flights of Archimedes Pump 1. *View looking up the barrel of Pump 1, cracking of the flights, note that crack visibility was enhanced by rust.*

sides of the flights. The reinforcement extends from approximately the third flight from the bottom of the barrel up to the drive shaft connection. The reinforcement was completed on September 9, 1997. The pumps were put back into service on September 11, 1997. The pumps were inspected on November 3, 1997, after an additional 1060.7 hours of operation on pump 1 and 1063.25 hours for pump 2. Two cracks of 1-inch and 3/4-inch long were found in pump 2; no cracks were observed in pump 1. The pumps were shut down due to high water on January 7, 1998. An additional 222.6 and 223.8 hours of operation were accumulated on pumps 1 and 2, respectively. An inspection of the pumps was performed at this time and no additional cracking was evident.

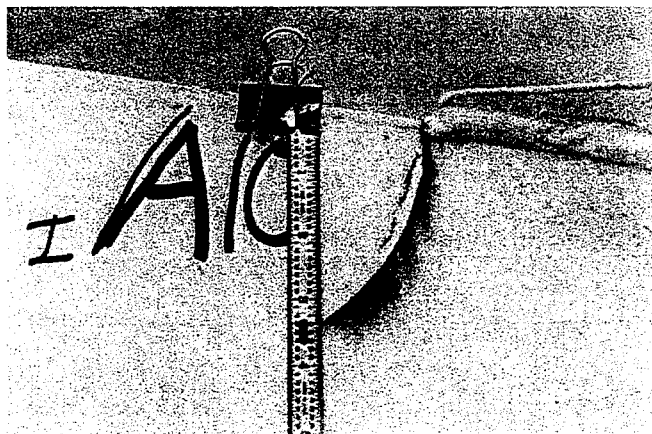
Figure 21. Typical fatigue crack propagation. *Cracking generally propagated perpendicularly from the edge of the weld. Note the abrupt material transition at the weld, responsible for stress concentration.*
